## Determination of impact sound insulation of floors in the laboratory according to EN ISO 10140-3

*The meaning of this test is to investigate the impact of a special screw on a floor construction. The screws were used to fasten gypsum boards on furring on the underside. The ceilings with the special screws were compared with acoustical steel studs with ordinary screwing.*

Innovation Skåne AB

A joists floor of wooden studs 45x220 at c/c 600 with 95 mm mineral wool and furring 28x70 at c/c 300 or Knauf AP Acoustical studs 25x85 at c/c 300.

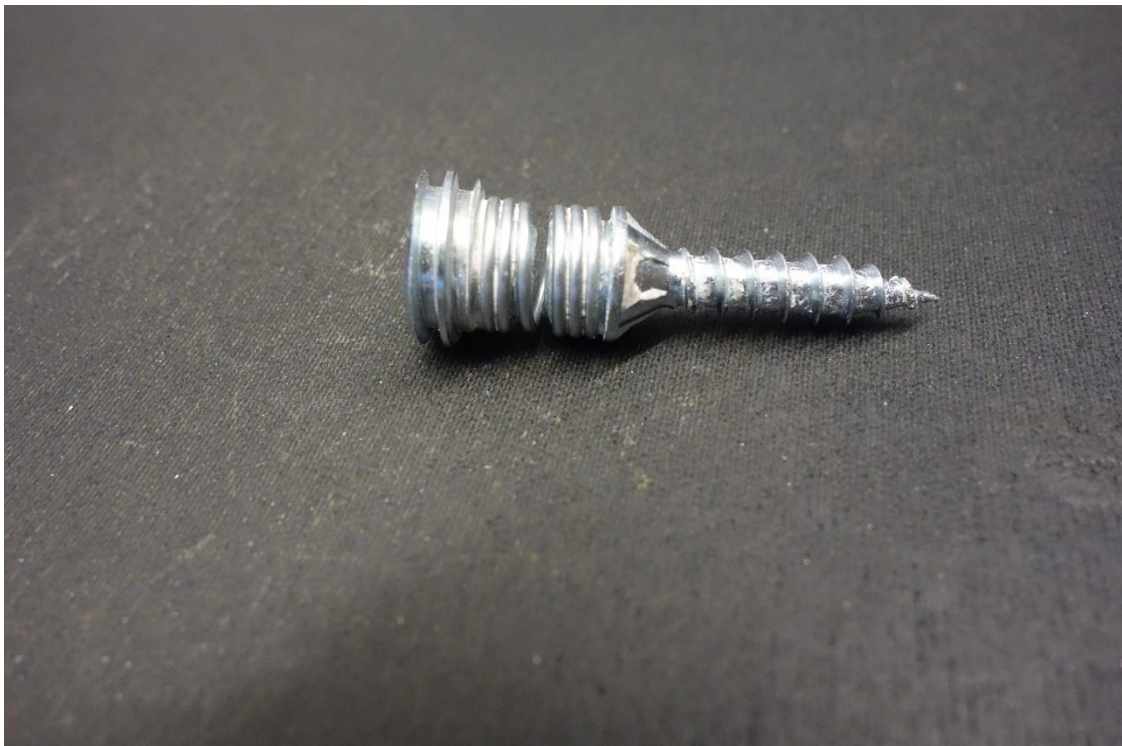
*Picture 1 – The special screw used in the test with the furring in enclosure 1 and 3.*

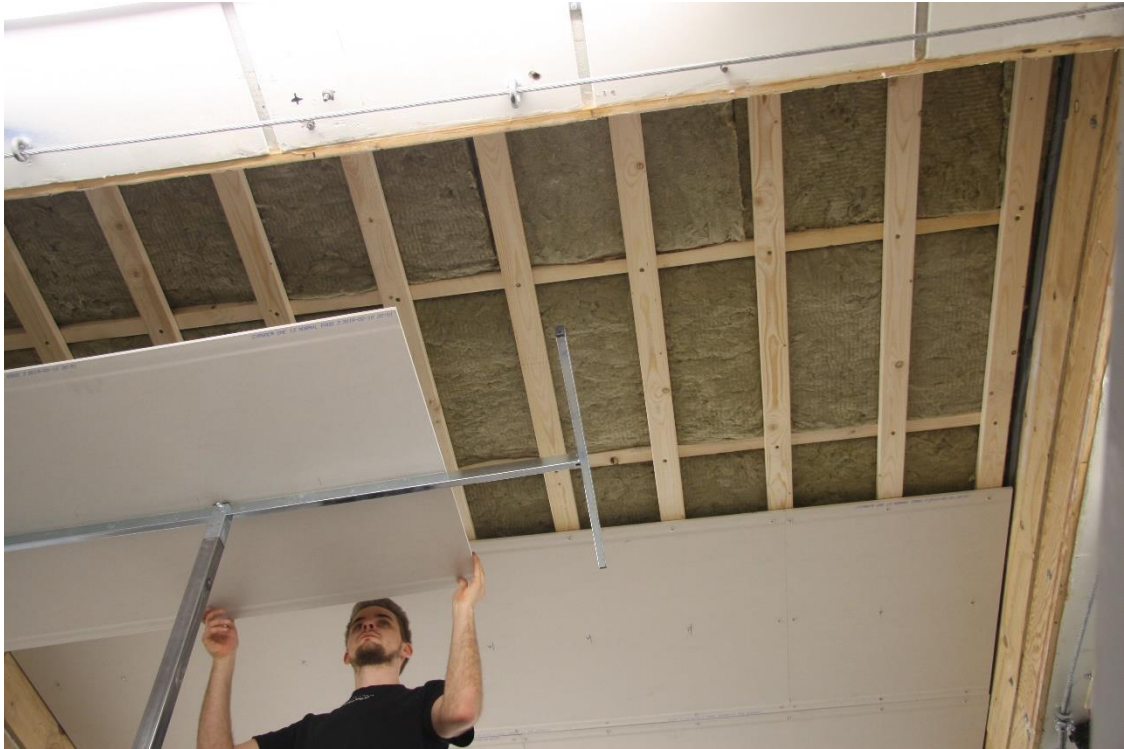
*Picture 2 – The floor from below. The furring 28x70 can be seen.*

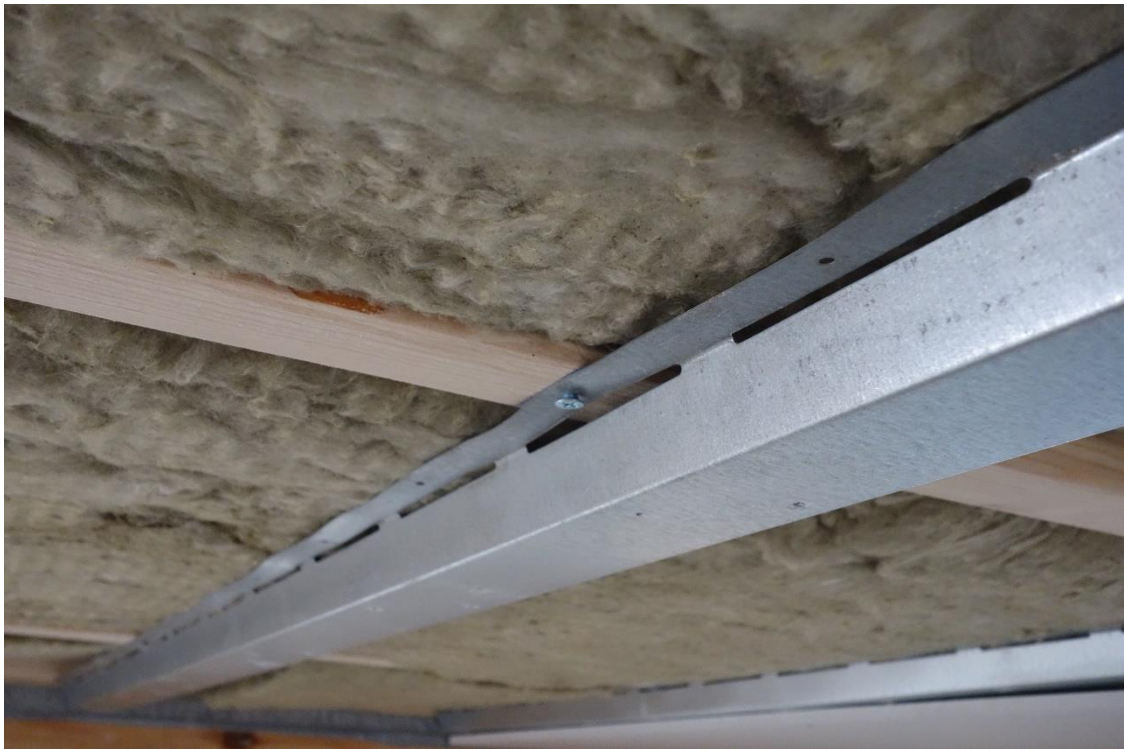
*Picture 3 - The Knauf AP Acoustical stud.*

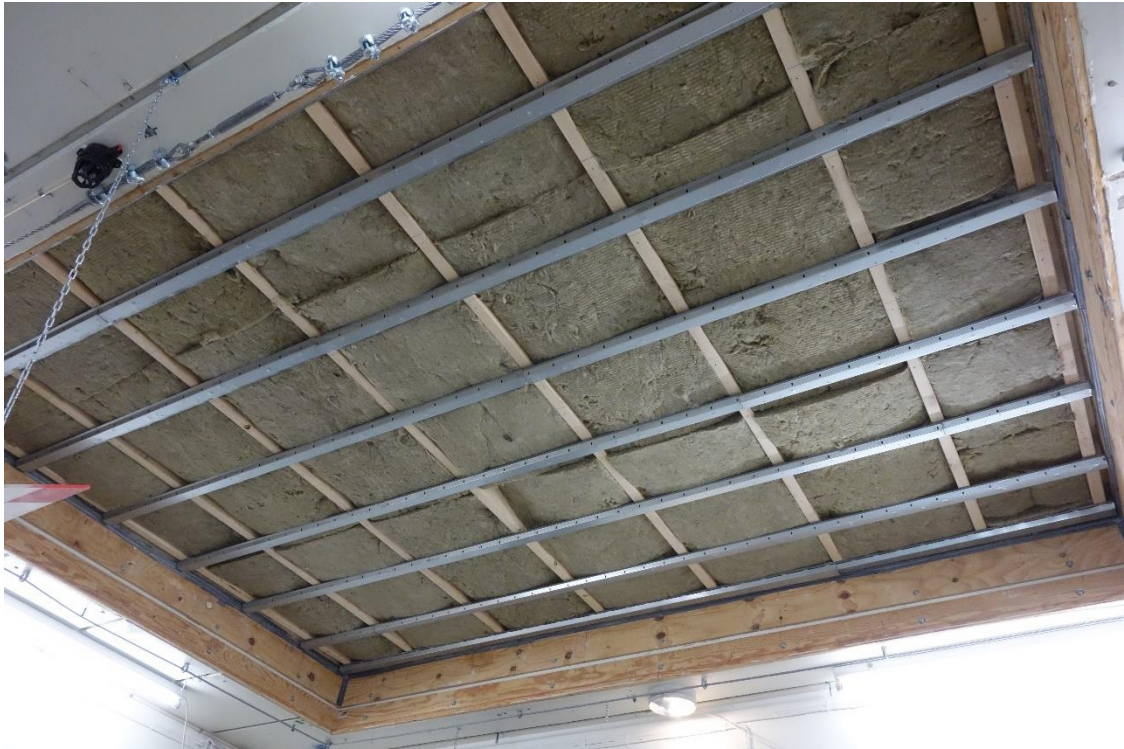
*Picture 4 – The floor from below with the Knauf AP Acoustical stud.*

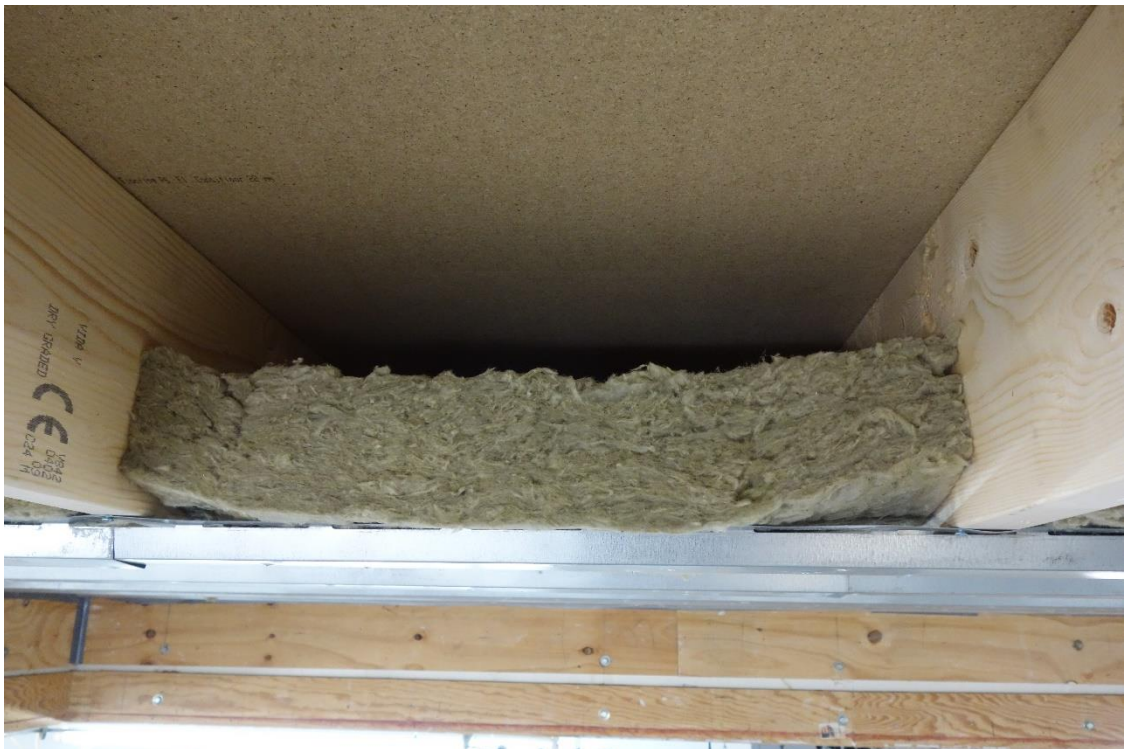
*Picture 5 – The mineral wool between the wooden studs 45x220.*

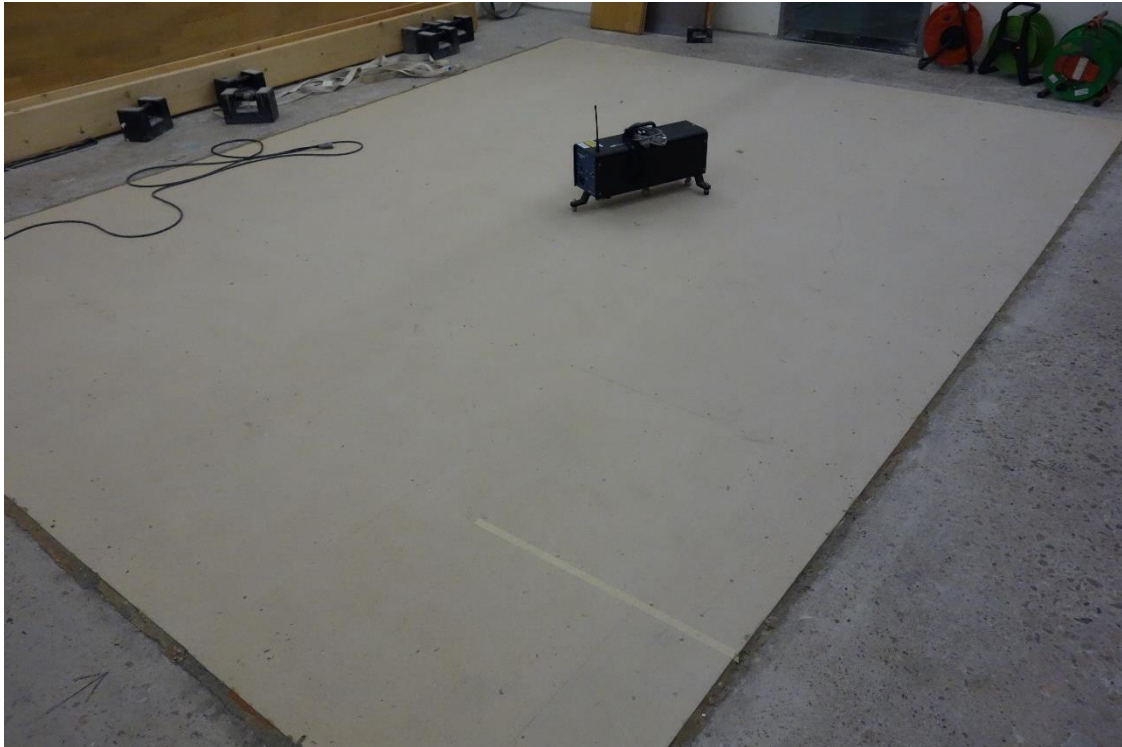
*Picture 6 – The floor from above, 22 mm chipboard.*

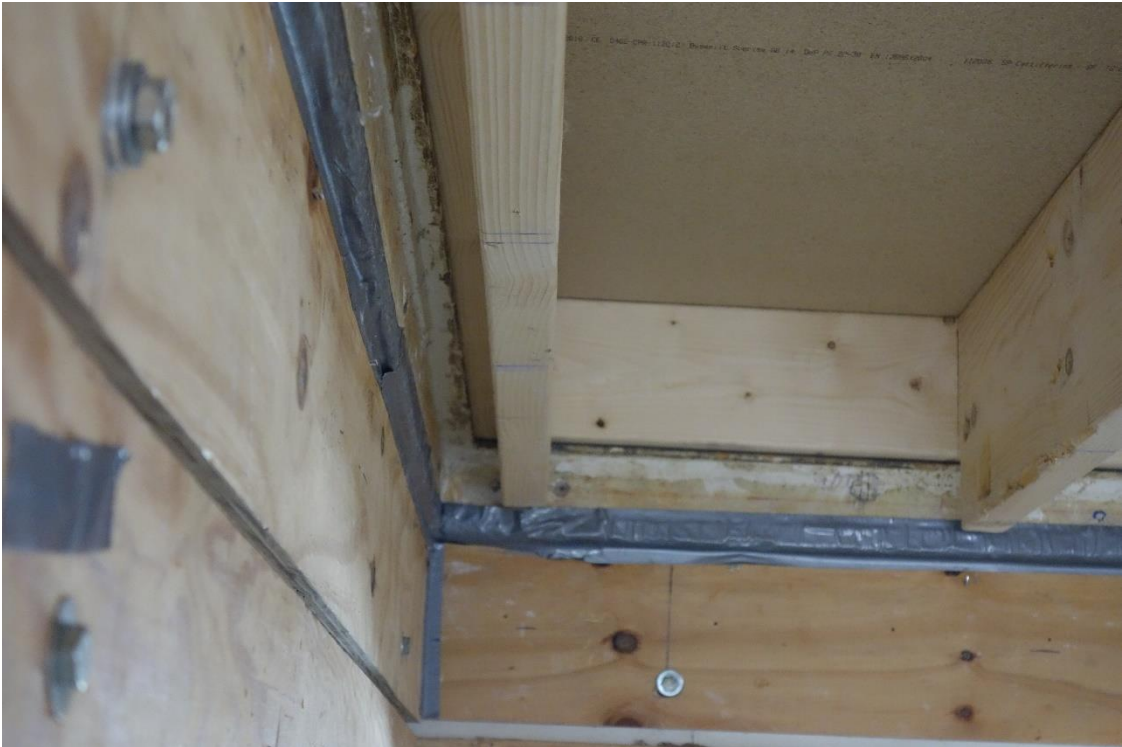
*Picture 8 – The wooden studs on the short side, 45x145 screwed into 45x220.*

The floors were built in SP:s sound insulation laboratory for floors (vertical measurements). The wooden studs 45x220 were attached by screws into studs 45x145 placed directly on the edges of the test opening on all sides (see the picture 7 and 8). The edges of the test object in the upper laboratory were covered by several strips of gypsum boards and sealed by tape and model clay.

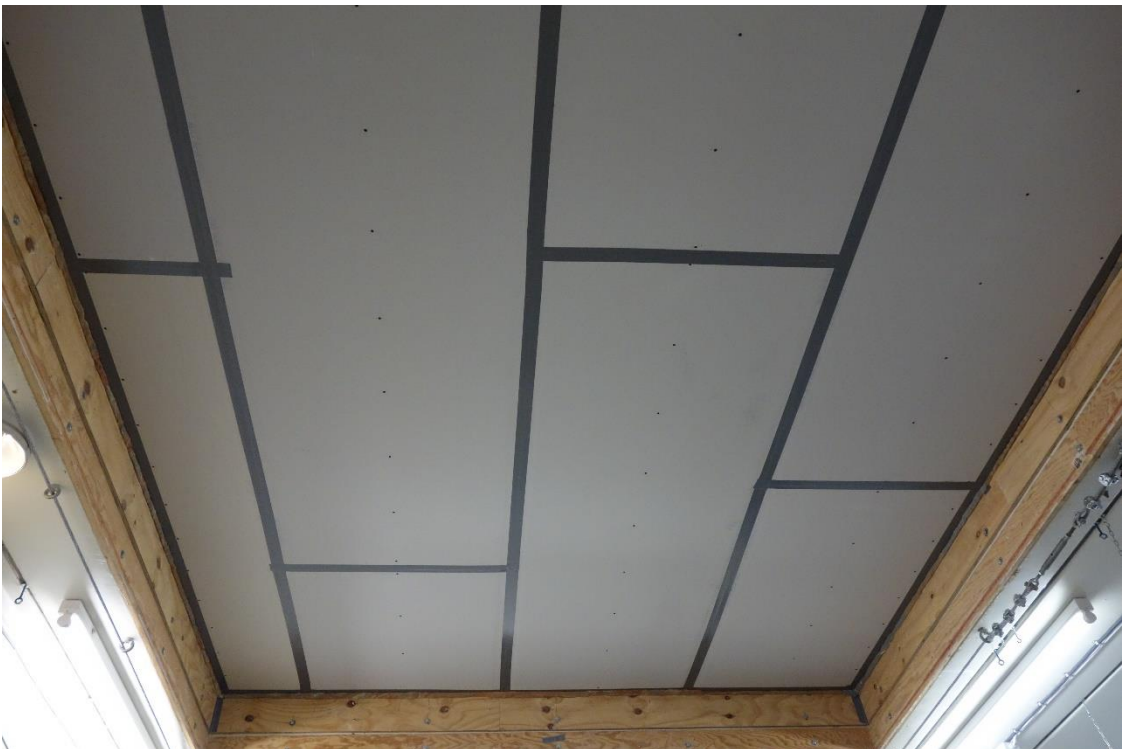
*Picture 9 – The gypsum boards from below, an example.*

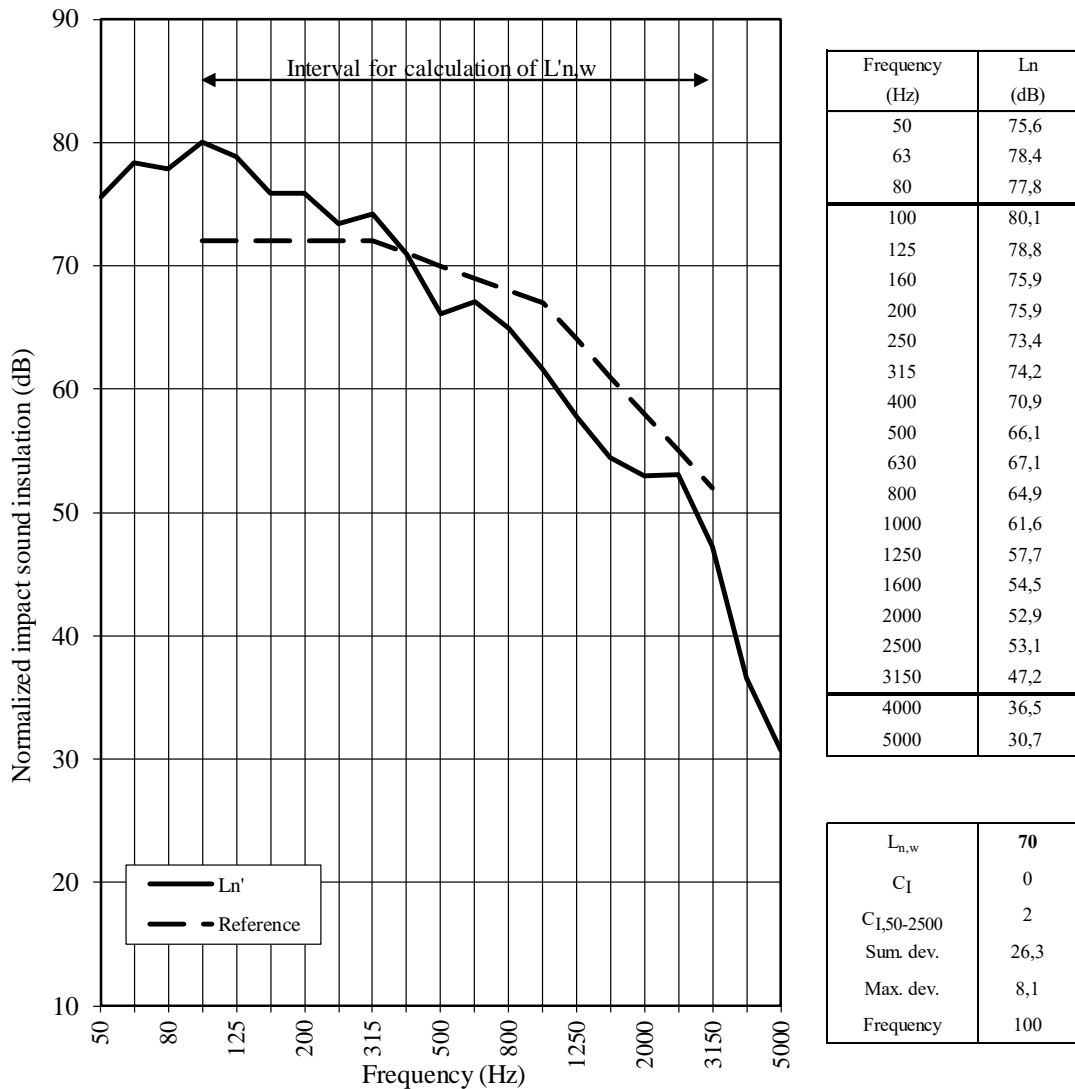
Appendix 1

**Determination of impact sound insulation according to EN ISO 10140-3**

Client: Innovation Skåne  
 Test object: A joists wood floor of studs: 45x220 at c/c 600 and 95 mm mineral wool and furring 28x70 at c/c 300.  
 On top: 22 mm floor chipboard  
 Under: **One layer of gypsum boards** fastened by **the special screws** at c/c 450 along each furring.

Test date: 2019-02-20  
 Receiving room volume: 138 m<sup>3</sup>  
 Results: Weighted impact sound level,  $L_{n,w}$  and spectrum adaption terms,  $C_I$  &  $C_{I,50-2500}$

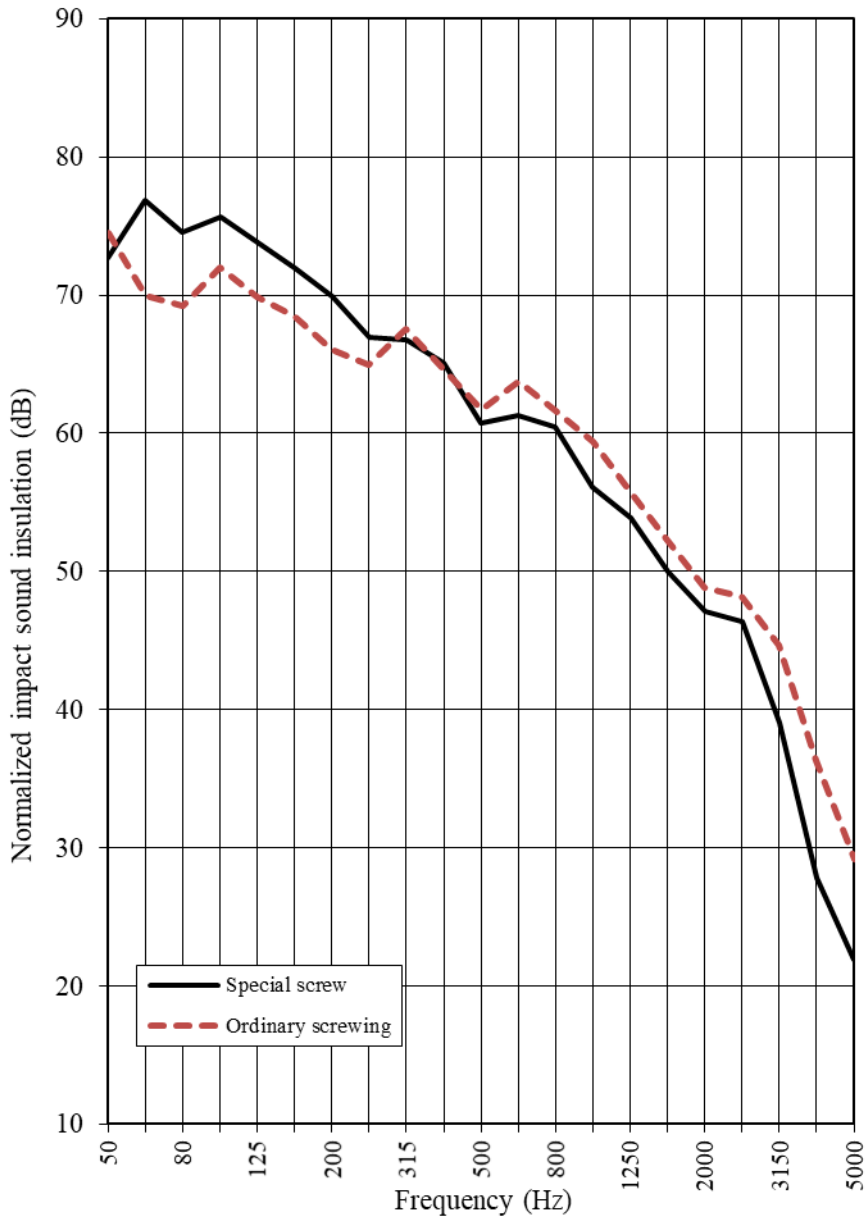
Appendix 6

**Two layers of gypsum boards** on the underside of the floor - The special screws compared with ordinary screwing on acoustical steel studs.

Lower values are better impact sound insulation.

Black line: The special screws

Dashed red line: Ordinary screwing on acoustical studs.

A direct comparison between the special screws and ordinary screws in acoustical studs is given in table 2 and in the enclosures 5 and 6.
